TECHNICAL REPORT ARCCB-TR-95022

# FRACTURE TESTING OF METALS AND COMPOSITES: TESTS AND ANALYSES FOR FAILURE PROBLEMS WITH ARMAMENT COMPONENTS

J.H. UNDERWOOD

MARCH 1995

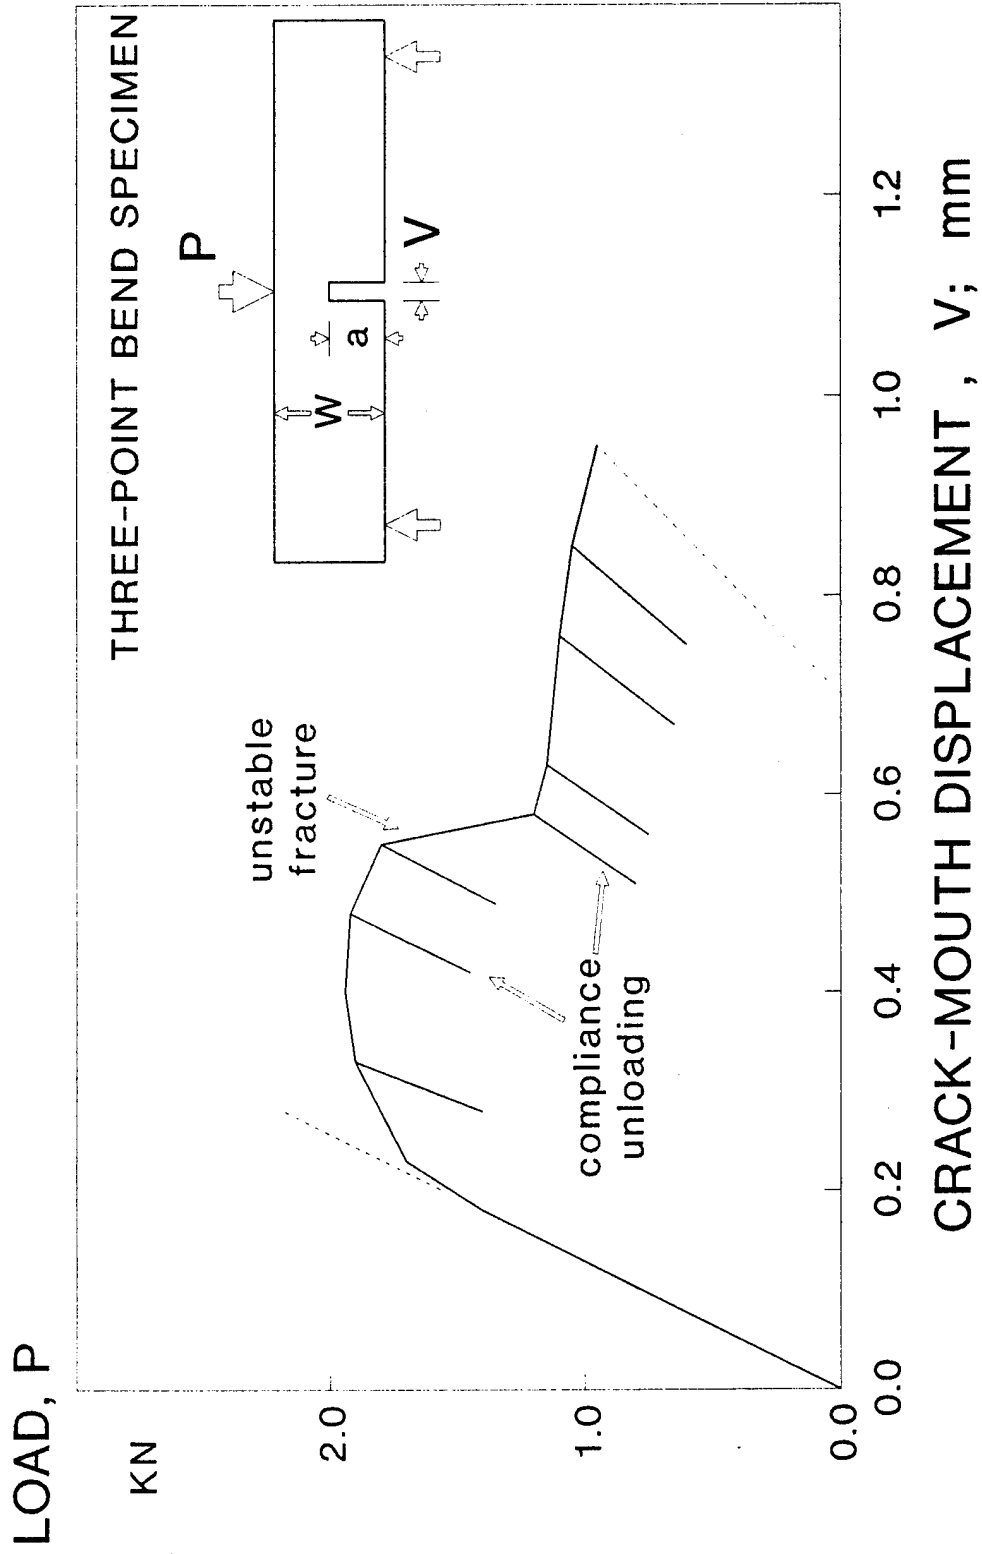
FIGURE 1

Figure 1 shows the key elements of a compliance unloading $J_{Ic}$ test used in failure analysis of a stainless steel welded structure (ref 4). Some details are given later. Two important points for the topic here, summarized in Figure 1, are as follows. First, the three-point bend configuration, generally regarded as quite simple to test, can now be used with a single, direct displacement measurement, $V$, at the crack mouth. Recent work (refs 5,6) has shown that $V$ can be used for J calculation as well as its accepted use in compliance unloading. This avoids the difficulties with measuring load-line displacement. Second, the compliance-unloading method allows crack growth measurement throughout the test. The test in Figure 1 used a relatively small specimen, with $W = 10$ mm, so that the crack growth caused large increases in crack length, $a$, relative to $W$, and the decrease in slope of the unloads related to the increase in $a/W$

A failure of the main welded box beam of a gun carriage occurred by fatigue crack initiation and growth and subsequent fast fracture of the welds over a significant portion of the beam cross section (ref 4). A key part of the tests and analyses conducted in response to the failure was a series of fatigue initiation life and $J_{Ic}$ tests, summarized in Table 1. Partial penetration welds in the box beam produced notches that became the initiation points for fatigue cracks, so notched bend specimens of the type sketched in Figure 2 were used for fatigue initiation tests. Initiation was defined as the number of cycles required for a crack to form at the notch root and grow across the 3-mm thickness of the weld. Later, the crack was grown further and the same samples were then used for $J_{Ic}$ tests, as indicated in Figure 1.

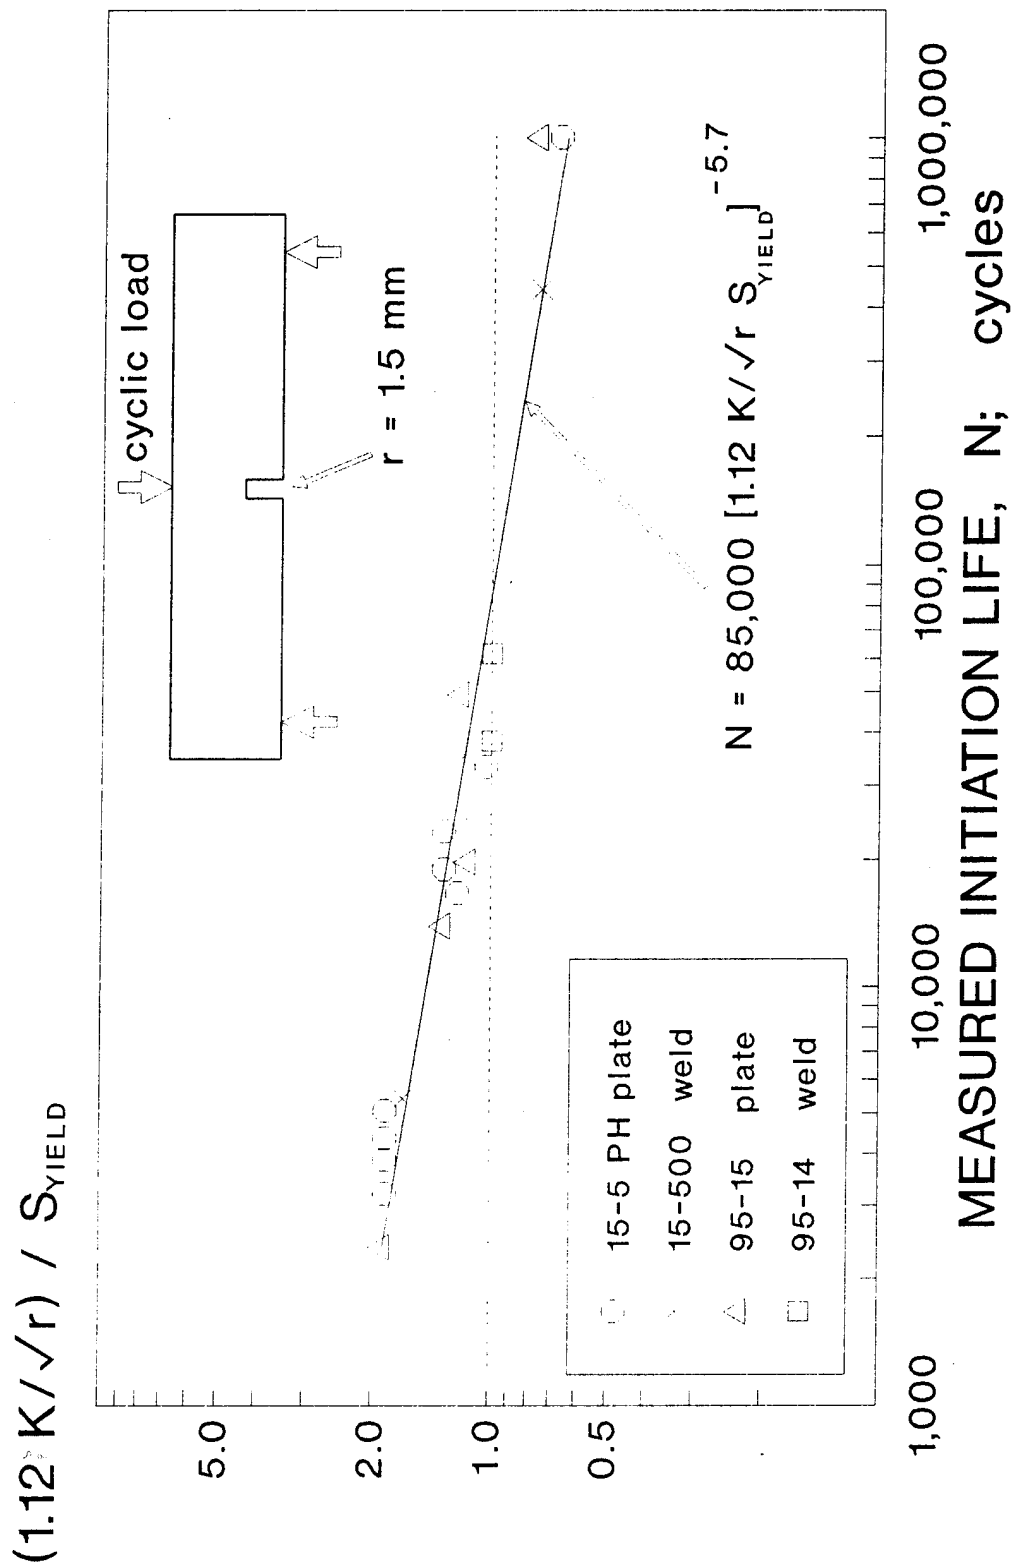
A summary of fatigue initiation results for the same welded structure mentioned previously (ref 4) is shown in Figure 2. The $K/\sqrt{r}$ analysis used by Barsom and Rolfe (ref 2) for low and medium strength steel structures gives a good description of the measured fatigue initiation lives for bend specimens of four different weld and plate samples of high strength stainless steel. The quantity $(1.12\,K/\sqrt{r})$ is a good estimate of the maximum stress at the notch root, based on the stress intensity factor, $K$, and the notch root radius, r. By using the ratio of the maximum notch root stress to material yield strength, an S-N plot of results from four different materials gives a single trend line that can be used for descriptions of fatigue initiation life and for life predictions for the courageous.

FIGURE 2
Fatigue life tests and analysis of
PH stainless steel welds and plate

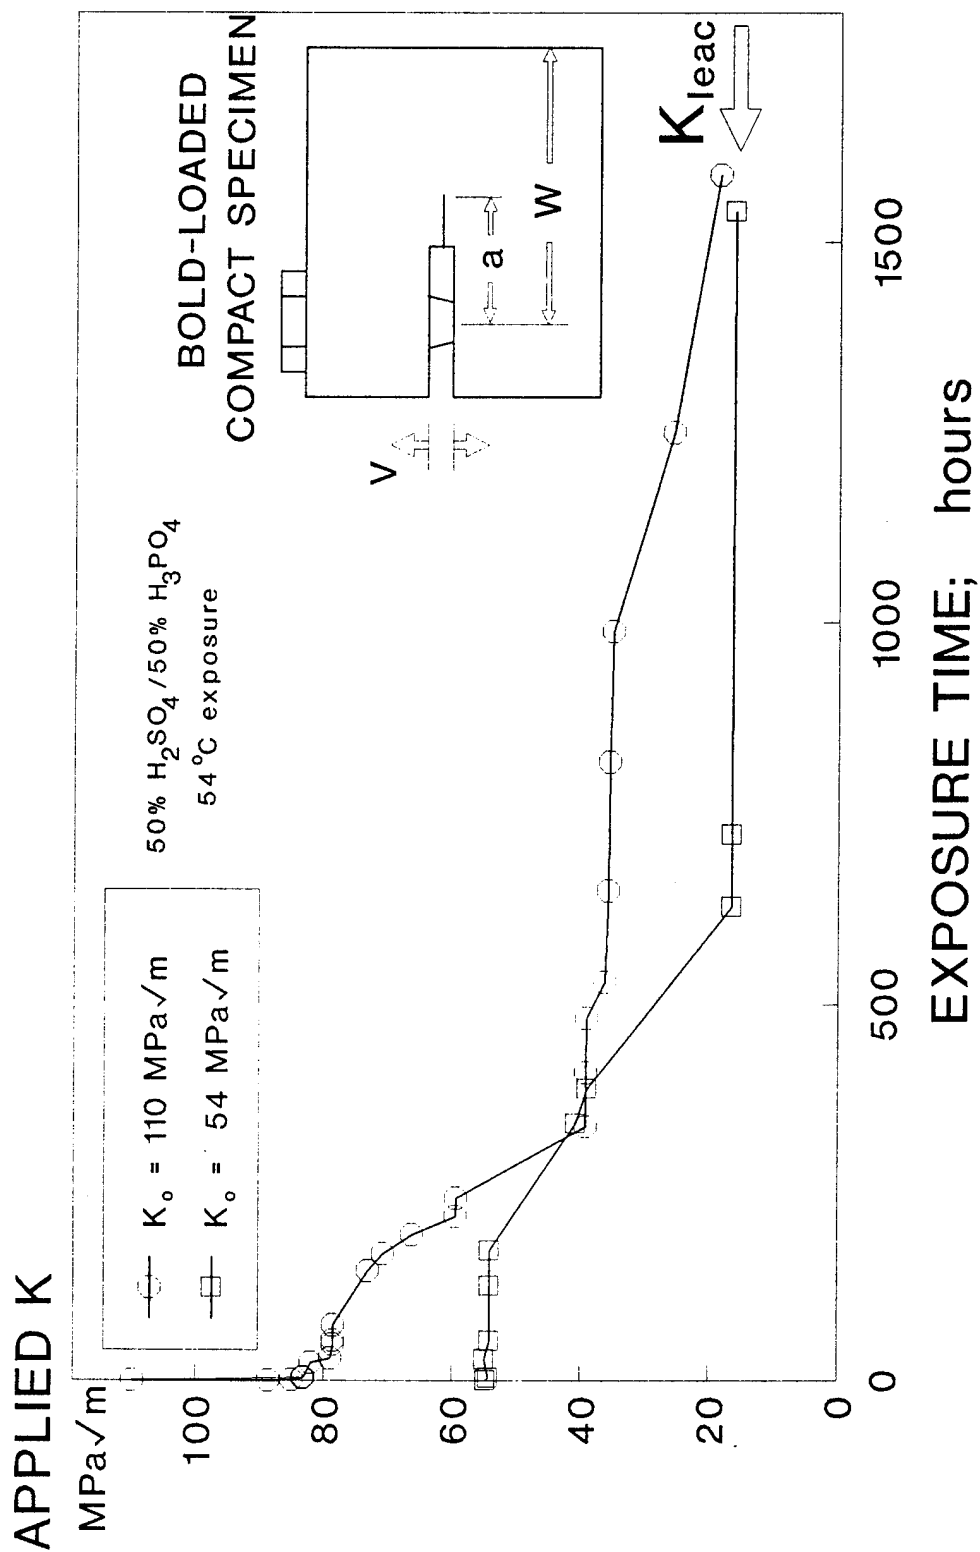
Test and analysis methods for describing environmentally-assisted cracking are addressed in Figure 3. Shown are the bolt-loaded compact test configuration and applied $K$ versus exposure time results for environmental cracking in a nickel-chromium-molybdenum high strength steel (ref 7). The bolt-loaded test is both simple and portable, which are considerable advantages when dealing with aggressive environments such as the warm acids in this example. An accurate $K$ expression is available in terms of crack mouth displacement, $V$, rather than in terms of load, $P$, as is typical. As the crack grows with increasing exposure time, the applied $K$ value decreases until a constant value is obtained, and this gives the value of $K_{Ieac}$, the threshold $K$ for environmentally-assisted cracking for this material and environment. Note in the results here the starting value of applied stress intensity factor, $K_o$, has no effect on $K_{Ieac}$, because considerable crack growth has occurred at low $K$ and the crack has grown beyond any effect of the prior higher $K_o$ value.

FIGURE 3
$K_{leac}$ tests of 1210 MPa yield strength

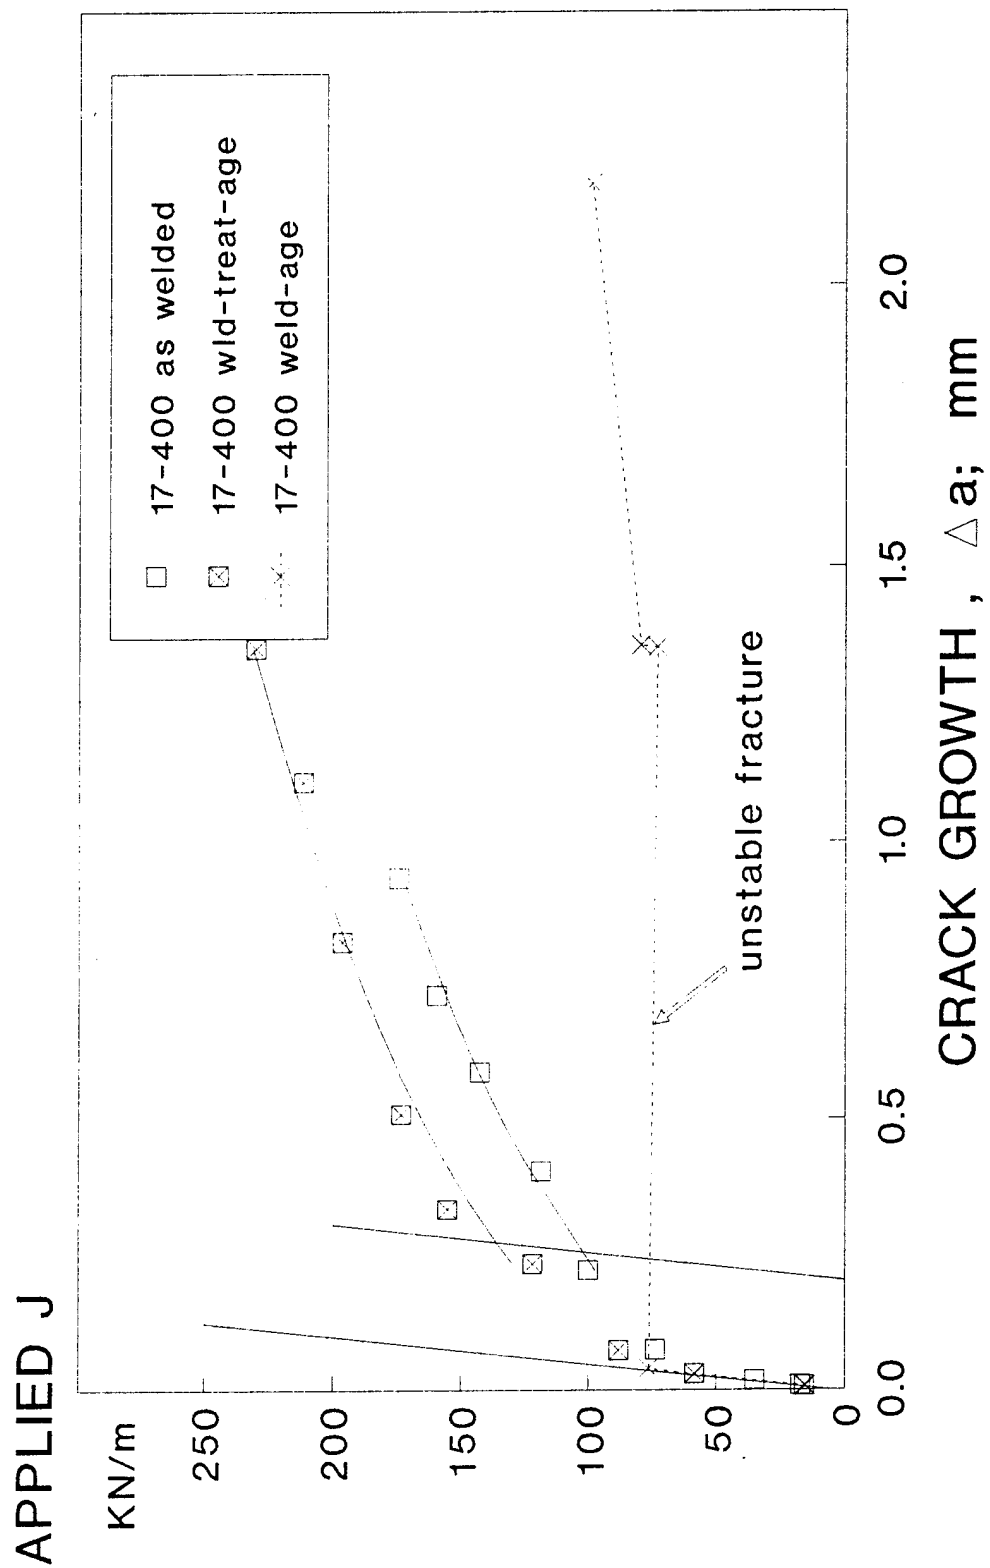
FIGURE 4

Results are shown in Table 1 for three heat treat conditions of 17-400 precipitation hardening stainless steel weld metal (AMS 5825 specification). As anticipated, the lowest initiation lives were obtained for the welds where the solution heat treatment was omitted, as sometimes happens in the case of a weld repair. The subsequent $J_{Ic}$ tests also showed this

omission of the solution heat treatment to give the worst results. The applied J versus $\Delta a$ plots from which the $J_{Ic}$ values were obtained are shown in Figure 4. Note that, as in the similar case discussed in relation to Figure 1, unstable cleavage fracture occurred for the weld-age heat treatment, leading to the lowest $J_{Ic}$ value. In addition, the J values beyond the $J_{Ic}$ point, such as at $\Delta a = 1$ mm (in Table 1), are significantly lower for the weld-age treatment.

$J_{Ic}$ tests of 17-400 PH stainless steel welds with various heat treatments

As a result of the failure investigation of the welded cannon carriage, it was recommended to use deeper penetration welds, to perform the complete solution treat and ageing procedure whenever possible, or if not possible, then to apply much stricter inspection criteria to the carriage.

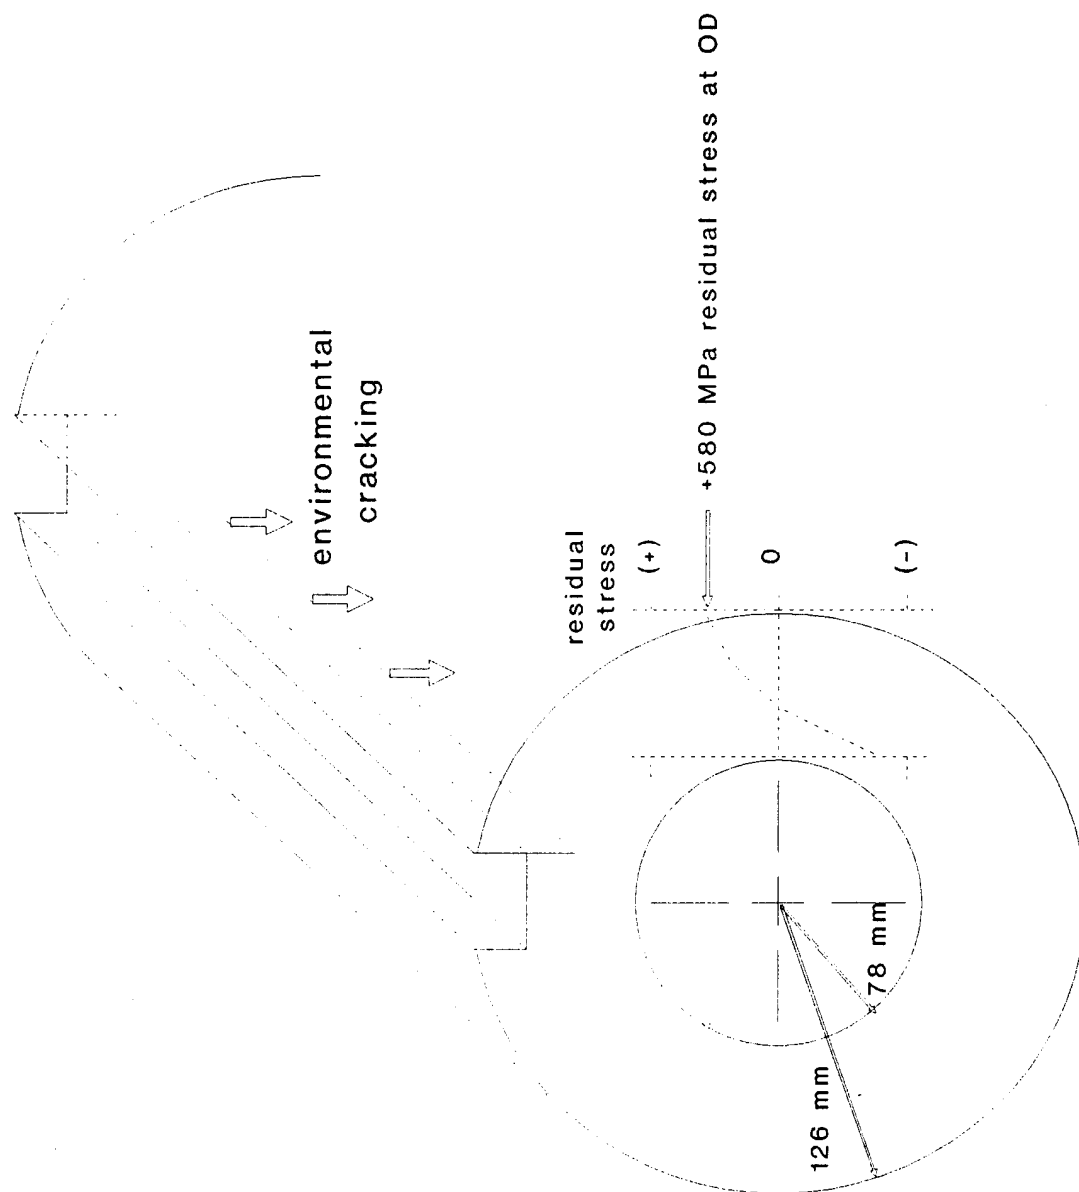
A quite unanticipated failure of a cannon tube occurred during a chromium plating process (ref 7). The tube was under no externally applied load whatsoever, and still a 1.7-m long crack grew entirely through the 48-mm thick wall of the tube. The test conditions eventually found to be crucial are shown in Figure 5 and listed in Table 2. The tube had a notch on the outer surface whose severity is only a little exaggerated (for clarity of presentation) in Figure 5. The tube also had circumferential direction tensile residual stress at the outer surface of about 580 MPa, due to an autofrettage procedure. The notch and residual stress combined to produce a yield strength level sustained tensile stress at the notch roots.

Sustained yield strength level stress alone could not have caused the failure of the A723 (ASTM specification) steel used for the tube. The steel had considerable fracture toughness, as indicated by the values of V-notched Charpy impact energy and fracture toughness in Table 2. It was the aggressive warm acid environment (see Table 2) combined with the sustained tensile stress that caused the failure. The sulfuric and phosphoric acid mixture at 54°C was used for electropolishing the steel before plating. Environmentally-assisted cracking was found to occur in this acid environment at values of applied $K$ as low as about 20 MPa√m in the tests described earlier in relation to Figure 3. This is only one-sixteenth of the value of fracture toughness--the applied $K$ at which cracking is expected in response to a single or sustained load without assistance from an aggressive environment.

FIGURE 5
Environmental cracking at an OD notch in
a cannon with tensile residual stress

As a result of the investigation, it was recommended to prevent or minimize contact of the acid with the notch root, if practical, or to significantly increase the notch root radius in order to reduce the value of sustained tensile stress.
